DEPARTMENT OF NATURAL RESOURCES
DIVISION OF OIL, GAS AND MINING

RE: Site Inspection, Deseret Generation and Transmission, Diamond Mountain Resources Mine, S/047/066, County, Utah

Date of Inspection: October 16, 2001

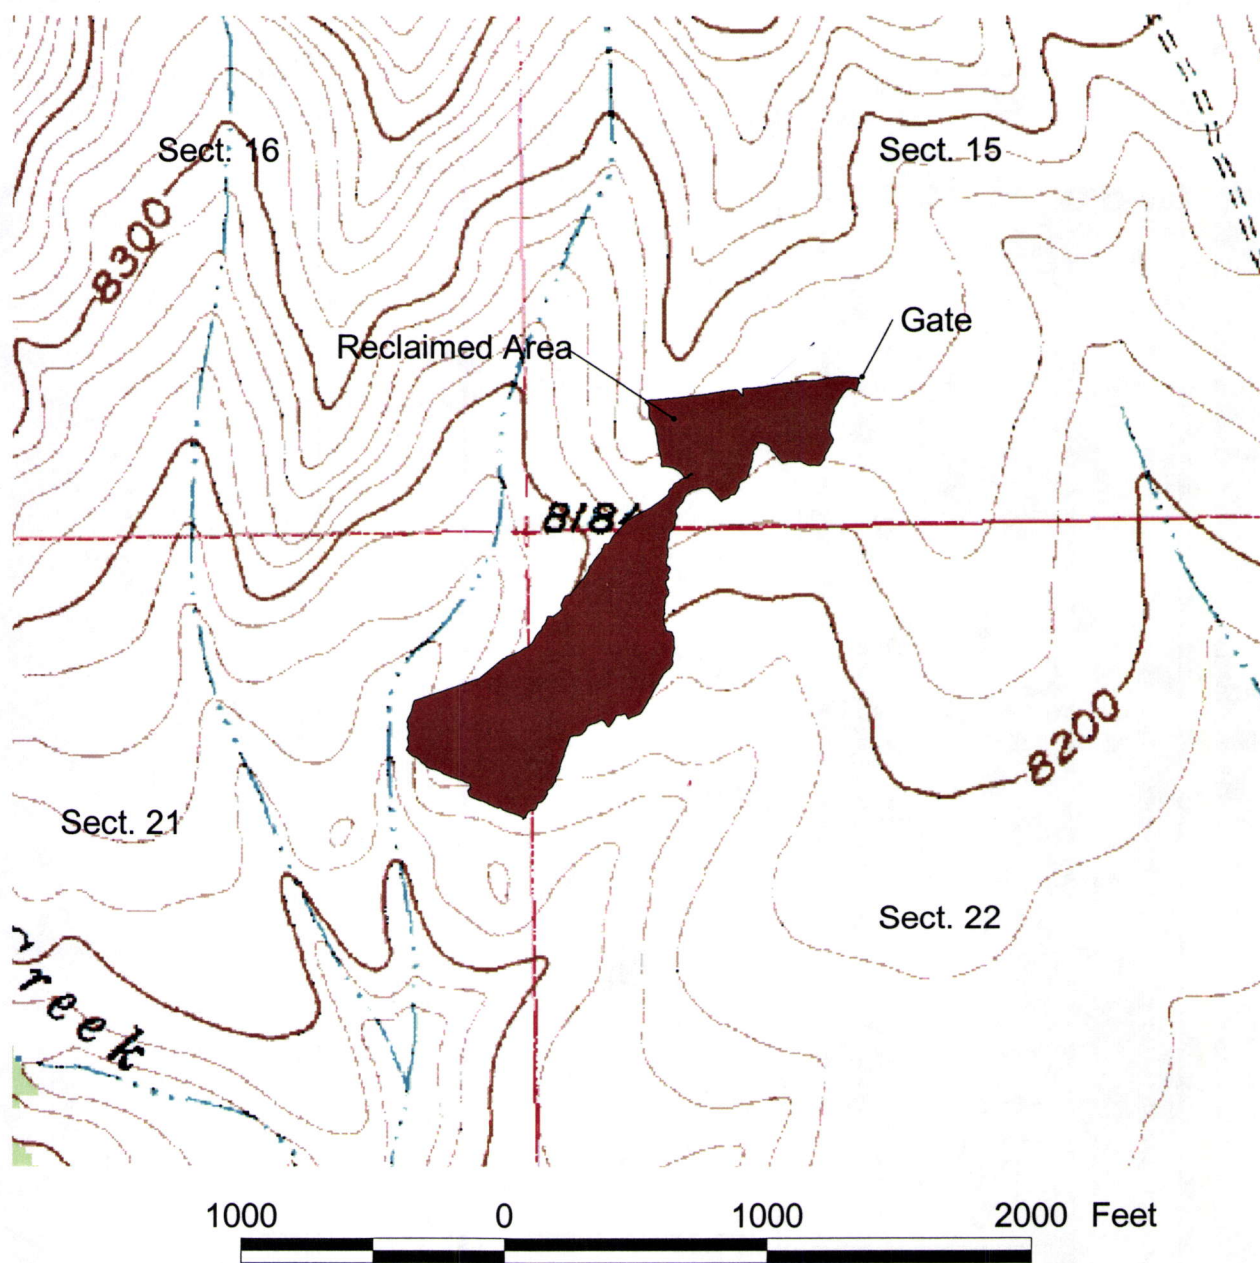
S/047/066

We took GPS readings around the area that has been disturbed, including the reclaimed area discussed in the previous paragraph. This data was downloaded and corrected using Pathfinder software, and the total disturbed area is 17.64 acres.

Prepared 10-17-01 by Paul Baker, Division of Oil, Gas and Mining, from information gathered 10-16-01. Total acreage: 17.64 acres. Quad Name: Burnt Cabin Gorge.
